The Bronnenberg House and 2005 Archaeological Investigations at Mounds State Park, Madison County, Indiana

Reports of Investigation 68

January 2006

Archaeological Resources Management Service
Ball State University
Muncie, IN 47306

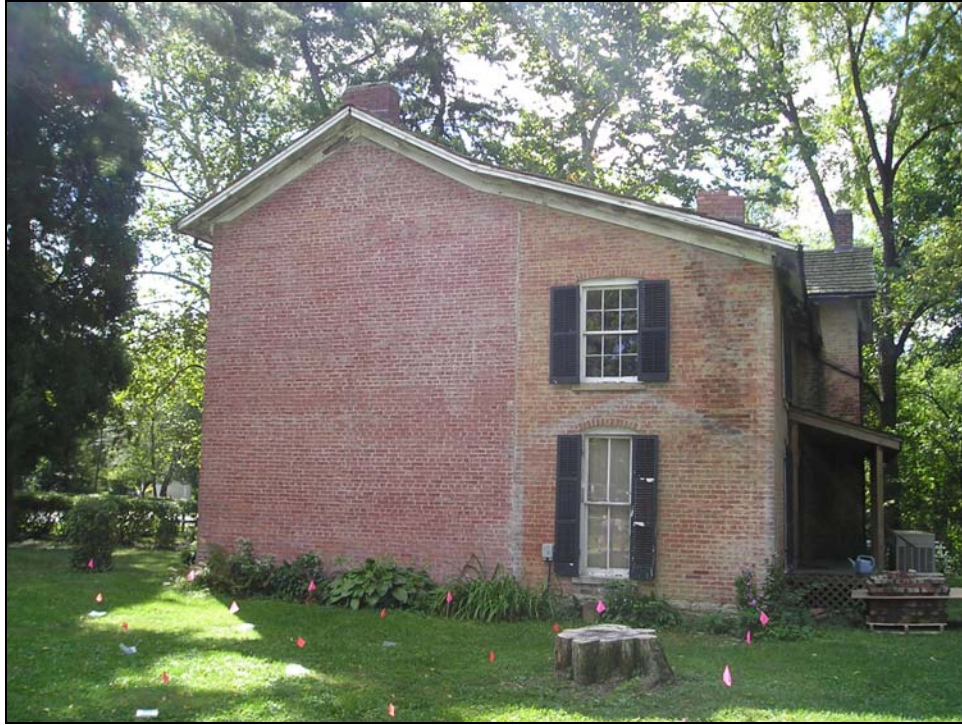
Figure 9. Photograph of the north side of the house showing the back addition and white outline of northern addition.

The current project focused on determining the location and function of no extant structures on the northern (side yard) and western (back yard) sides of the Bronnenberg House. A photograph circa 1890 shows an addition of the house on the northern side that is no longer standing (Figure 7). This addition did leave a shadow remnant on the northern side of the house where it was once attached (Figure 9). A photograph circa 1930 shows a large structure separate from the house on the western side (Figure 8). By 1931 this structure is absent (Figure 10). This structure was identified as a root cellar/smokehouse/summer kitchen (Hicks 1979:25) (Figure 3). A well is also reported to be in the western yard (Hicks 1981:25).

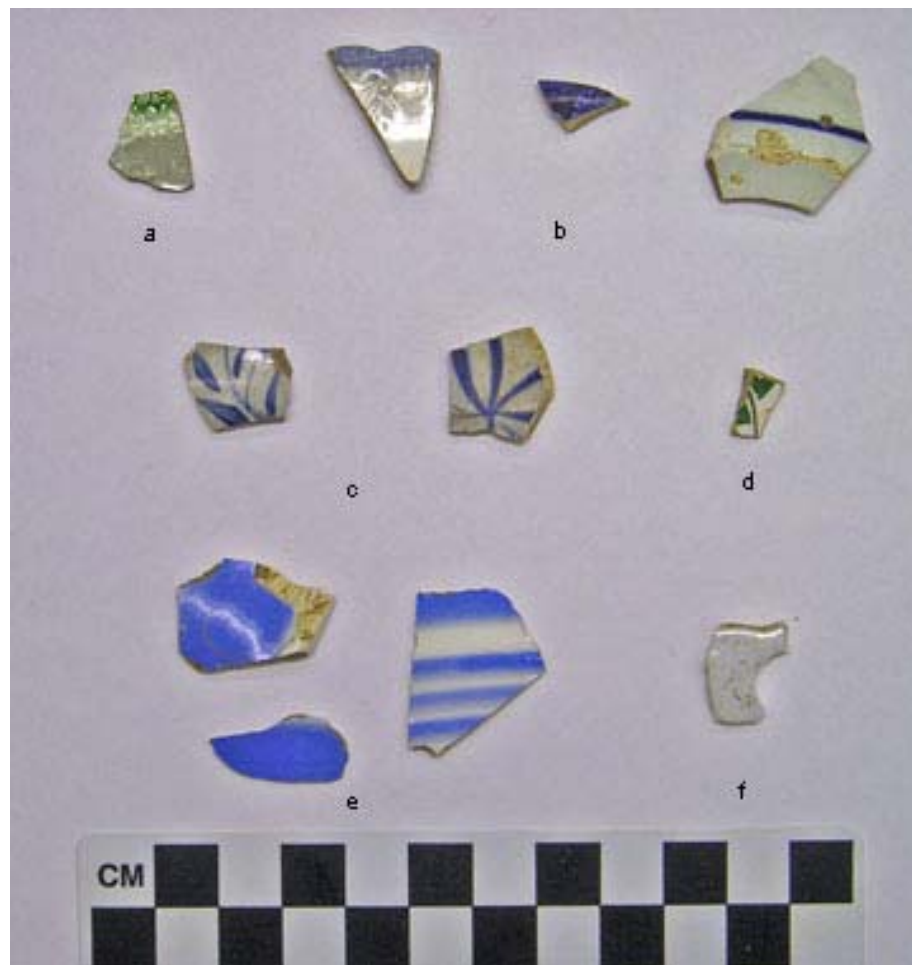
and hand painted whitewares, and one transferprint on porcelain (Table 2) (Figure22). The porcelain fragment was recovered from the back yard. A mean ceramic date for the ceramics in the sideyard was 1845.8. Combined with the historic documentation, this date fits well with the original construction of the house between 1840 and 1850.

Figure 22. Decorated ceramics: a) molded edge, green glaze; b) flow blues; c) handpainted blue florals; d) handpainted polychrome floral; e) annular bands; and f) gilt transferprint.
